CASE STUDIES

TWO WALL PERIODONTAL BONE DEFECT

Case from Dr Renukanth Raman, Malaysia

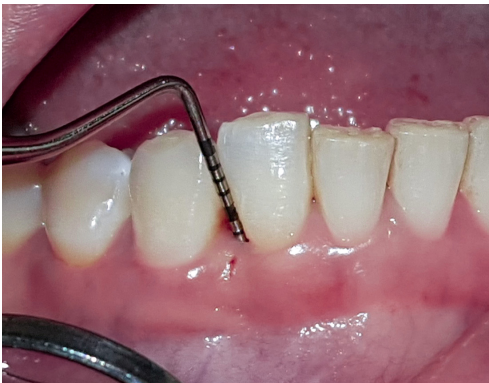
2. Pocket depth 8mm

8mm probing pocket depth on tooth 42(d)

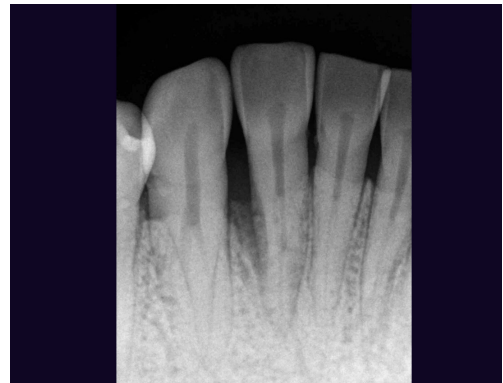
3. Pre-op scan shows what appears to be two-wall defect

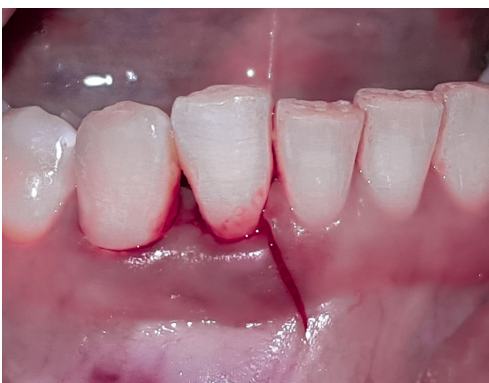
4. Less invasive papilla-preserving flap is raised as no collagen membrane is required

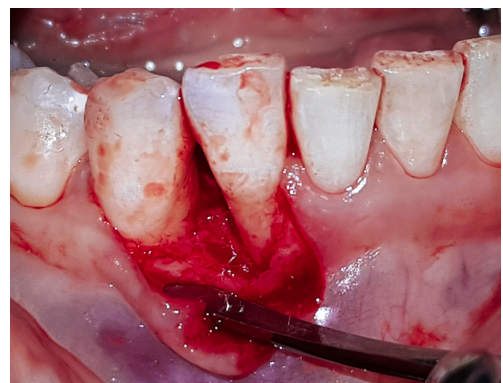
5. Defect visible

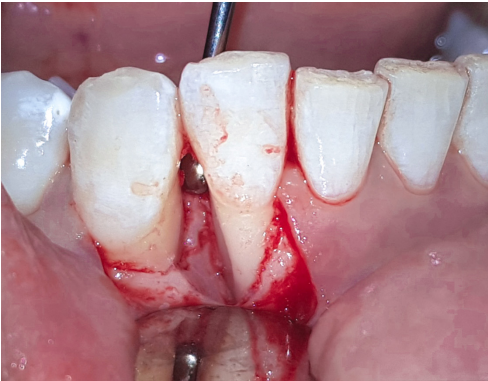
6. Osseous and root surface debridement reveals deep two-walled intrabony defect

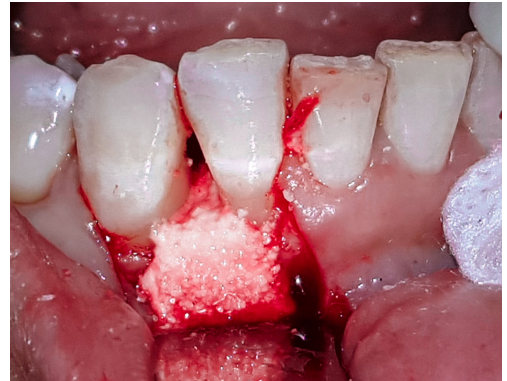
7. EthOss® bone grafting material placed and shaped/ moulded

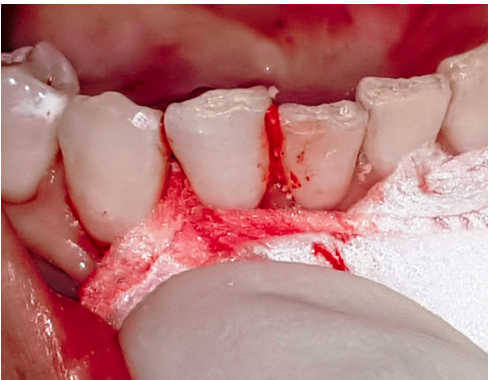
8. EthOss bone grafting material dried with sterile gauze for 5-6 minutes

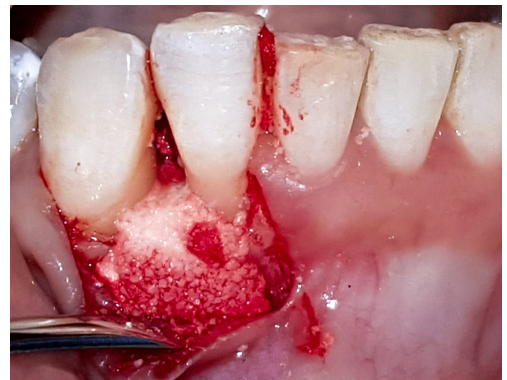
9. EthOss bone grafting material sets

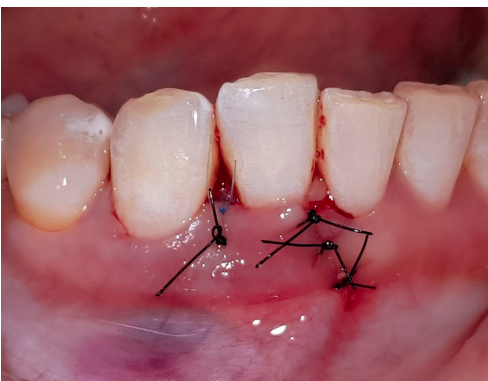
10. Suturing, passive primary closure

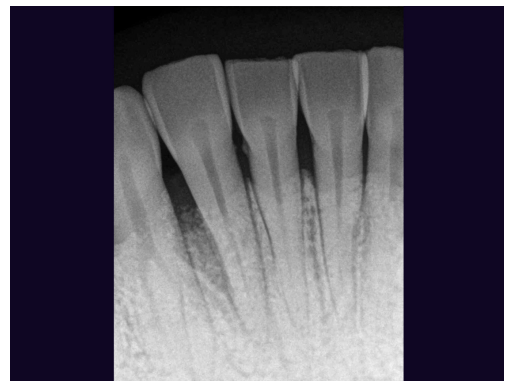
11. Radiograph immediately following graft placement

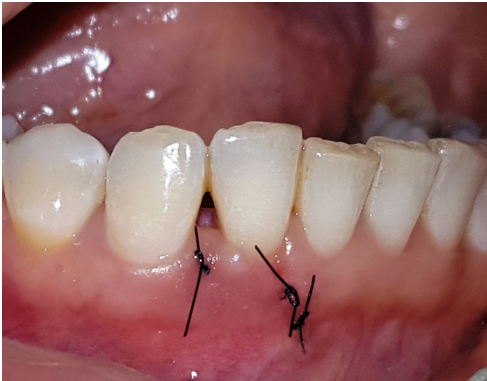
12. 1 week post op

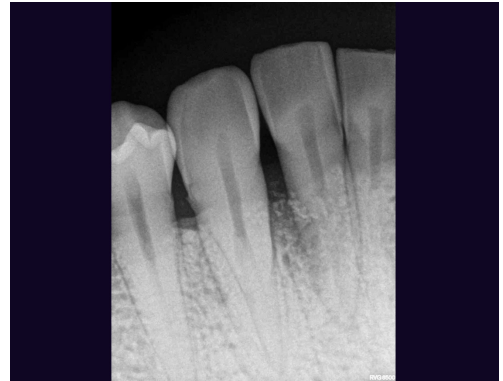
13. Radiograph at 2 months, slight radiopaque view of grafted area, this is to be expected as the Calcium Sulphate resorbs

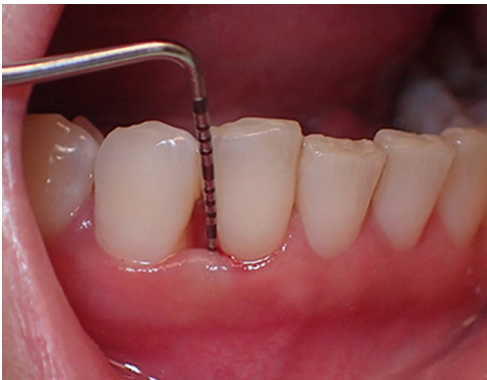
14. 1 year post op, 3mm probing pocket depth, good soft tissue healing

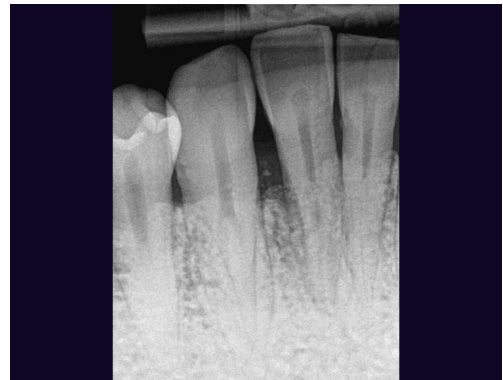
15. Radiograph at 1 year
